**DECLARATION OF AMIT OZA  
IN SUPPORT OF DEFENDANT'S  
MOTION FOR COUNTER-SECURITY**

- 1.3 The matter concerns the collapse of No. 1 crane of the "RISHIKESH" which unfortunately resulted in the death of the crane operator. The "RISHIKESH" is a 5 hold bulk carrier with five cranes. No 1 crane is located on the foc's'le and is manufactured by M/s Brissonneaux & Lotz Marine (BLM), France.

6184/CM/DH  
"RISHIKESH"  
Page 1 of 38

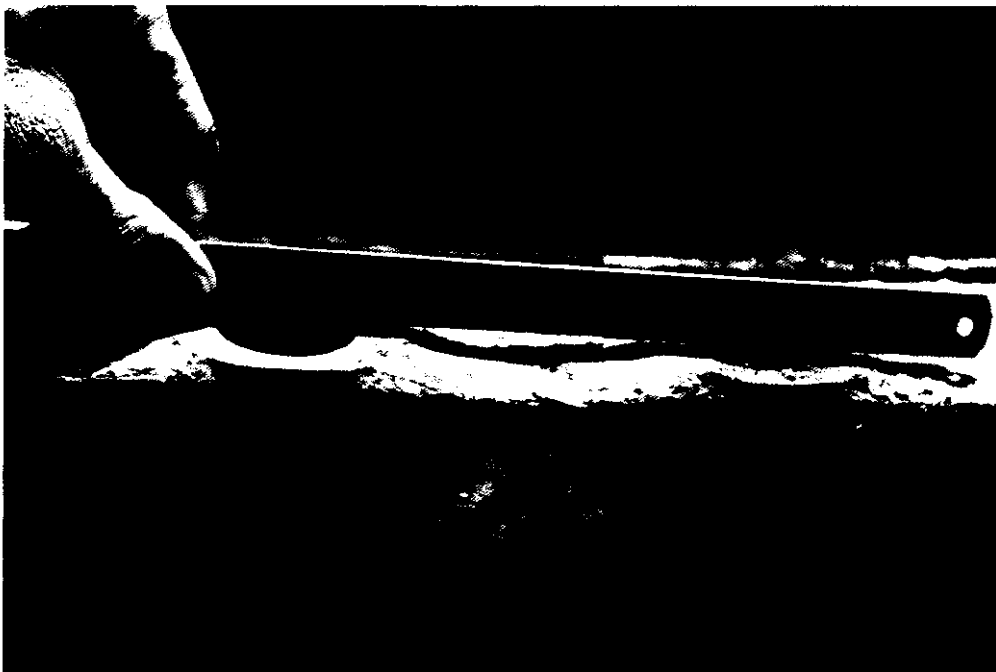
**Figure 64, General view of the segment of outer slewing ring which fractured.  
The surface shown would have been in contact with the upper flange.**

**Figure 65, General view of fractured outer slewing ring showing the surface that would have been in contact with the stud washers.**

**Figure 66, Close-up view of one of the fracture surfaces**

**Figure 67, Close-up view of the other fracture surface. The fracture has occurred at the assembly/inspection plug.**

**Figure 68, View showing wastage of fractured outer slewing ring race between the stud holes**

- 3.4** The slewing ring fractures were instantaneous fractures caused by sudden high bending type loads and must have occurred during the actual crane toppling process.
